Avanti/UMSI Itron MV-RS AMR System Survey
For: City of Opa-Locka, Florida.

By: Eric Corey, Dave Ratter, Jason Wilczek
Submitted to: Miami-Dade/Opa-Locka AMR Team

March 14, 2017

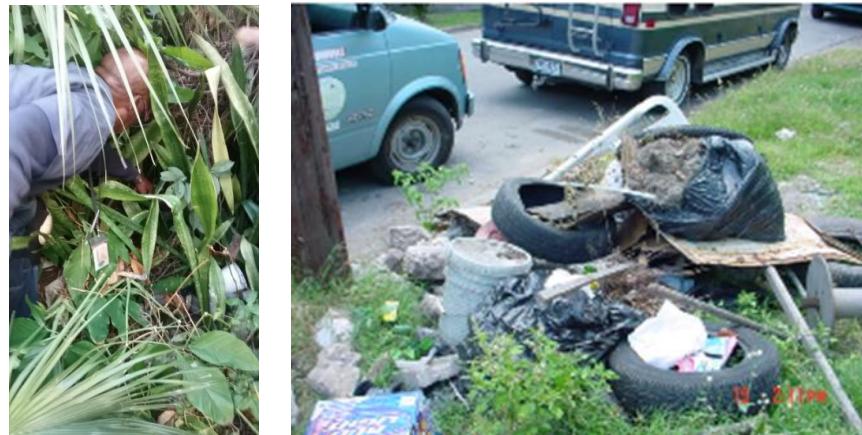
FIG 2:

Following are additional **Miscellaneous** reasons found for UMSI not performing an AMR Survey that total 183 customers (See FIG 2, next page):

As discussed on 1/31/2017, to further assist Opa-locka Public Works in completing their Scope of Work and achieving the goal of 100% Opa-locka meters surveyed, Avanti recommends spending another full day in the field with Johnny (See above FIG 2) live certifying him to perform an Itron AMR ERT/Meter Survey, and afterwards, Airia Austin assign Johnny to AMR Survey above mentioned remaining Opa-locka meters.

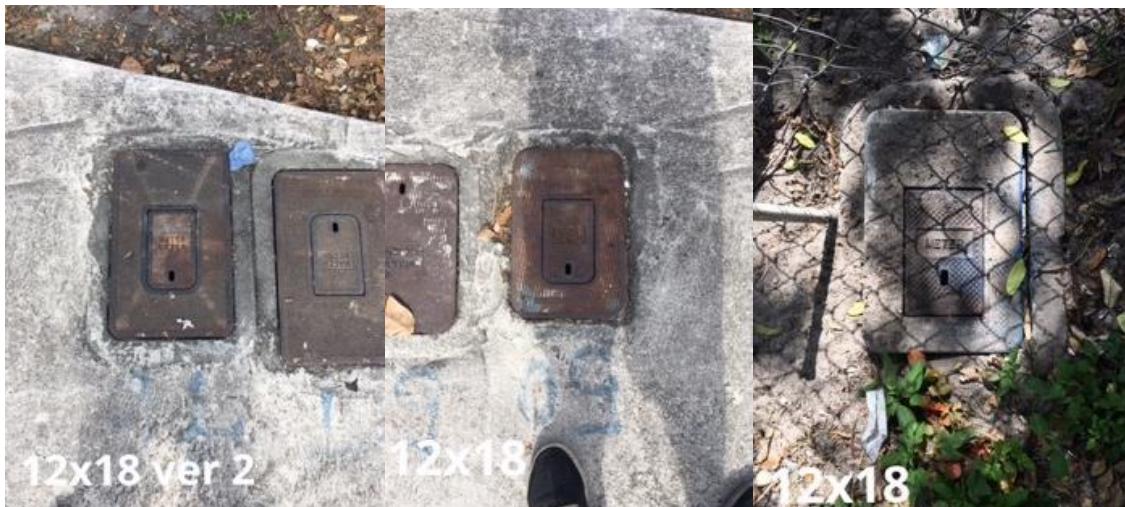
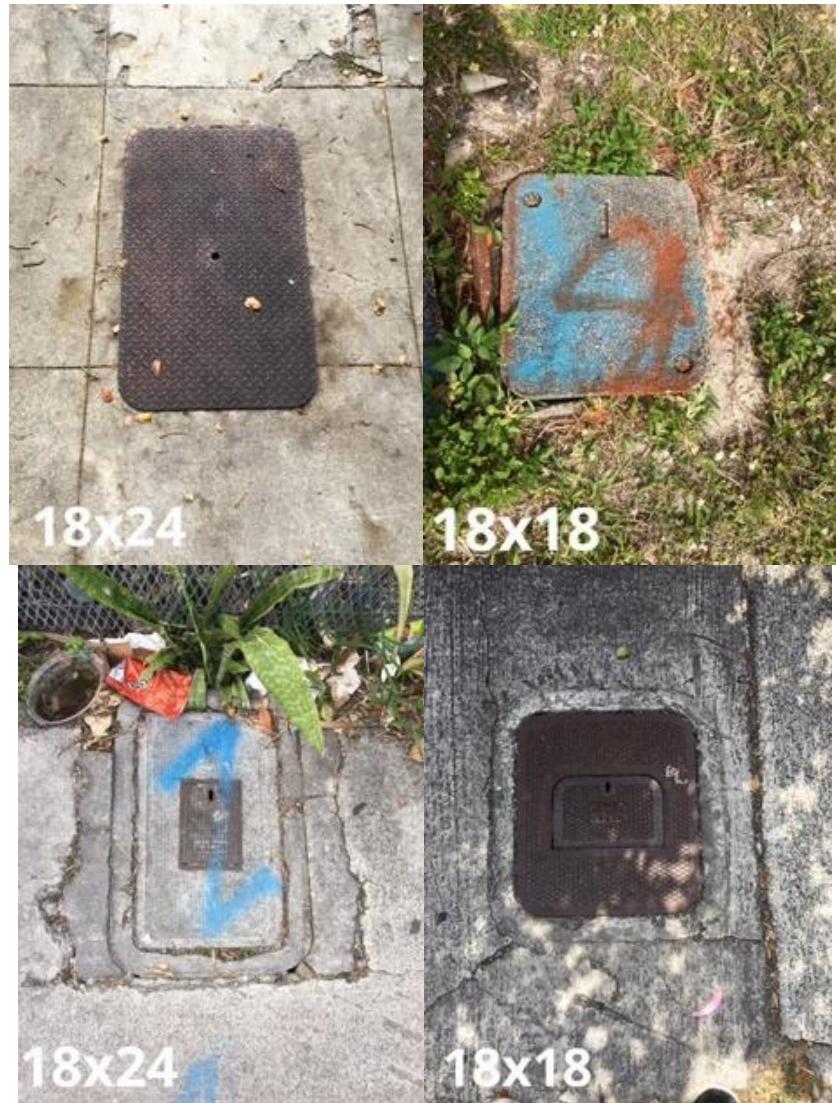
Pit Lid Examples:

<i>Missing Meter Box Lids</i>	= 61
<i>Damaged Meter Box Lid</i>	= 245
<i>Meter Boxes in Poor Condition</i>	= 315
<i>Meter Boxes in Fair Condition</i>	= 26
<i>Meter Box Missing or Broken</i>	= 62

To assist will visually locating the water meter, as shown above, Opa-locka Public Works spray **paint a blue mark, arrow, etc.** during the Annual ERT/Meter audit performed.

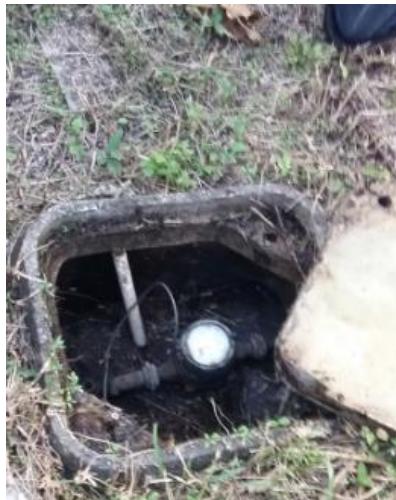
FIG 3:

Fogged Lens means the glass lens on the water meter register no longer has a water tight seal (see FIG 3) resulting in the lens being clouded with moisture.

If Fogged Lens, at a minimum, the register needs to be because the register lens glass lens seal is defective due to either manufacturer defect (this is typically rare) or vandalism.

Register is loose means the water meter register is no longer securely attached to the top of the water meter body.

If the Register is loose, possibly due to vandalism, on a PD meter, the register magnet will not fully interface/connect with meter body chamber magnet resulting in inaccurate measurement of water flow, and of course, also an inaccurate visual and AMR meter reading.

Itron training for annually scheduled meter pit box audit inspection of every water meter to visually confirm if register lens is Fogged and Register is securely attached to the water meter body (among several other things to visually confirm). See FIG 4 for picture of Itron recommended Pit ERT Installation.

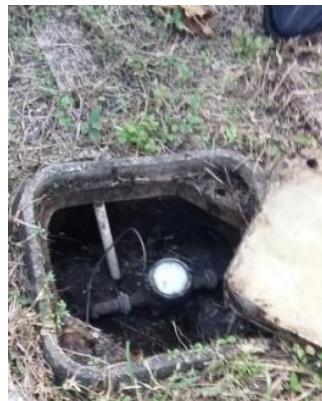
FIG 9:

- a) Moisture overtime will wick (i.e., travel) up the exposed bare wire **to the ERT** unit and damage the electronics of the ERT unit (i.e., water and electronics do not mix).
- b) Moisture overtime will wick (i.e., travel) up the exposed bare wire **to the Register** causing the glass lens to be fogged and damage the electronics of the Register (i.e., water and electronics do not mix).
- c) AMR meter reading collected from the disconnected ERT is a “**memory meter read**” from the last time the ERT cable was connected to the water meter register which is typically seen as low consumption or even no consumption meter reading from last month’s meter reading; thusly, erroneously reporting of the actual meter reading that should be collected and billed for the customer.

(Note: this is intentionally the same pic as Fogged Lens to illustrate an example of a **multiple issue** and the importance of an Annual Meter Audit – ERT is missing!):

MV-RS identifies the disconnected ERT in a MV-RS Report via the **Cut Cable Tamper** indicator built into the ERT device.
