Avanti/UMSI Itron MV-RS AMR System Survey
For: City of Opa-Locka, Florida.

By: Eric Corey, Dave Ratter, Jason Wilczek
Submitted to: Miami-Dade/Opa-Locka AMR Team

March 14, 2017

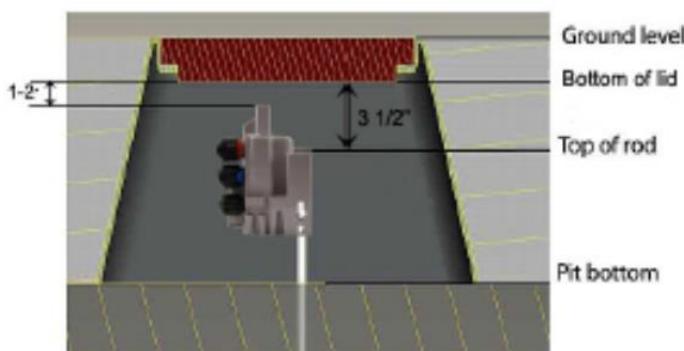
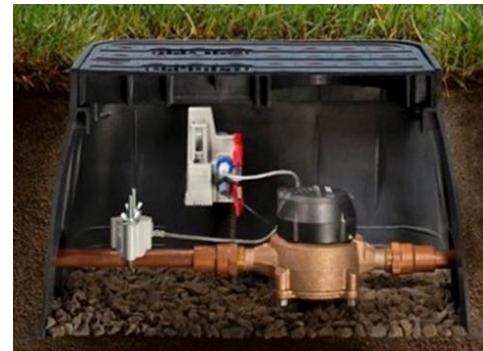
FIG 4:

Itron recommended Pit ERT Installation:

Itron training for annually scheduled meter pit box audit inspection of every water meter to visually confirm if register lens is Fogged and Register is securely attached to the water meter body (among several other things to visually confirm). See FIG 4 for picture of Itron recommended Pit ERT Installation.

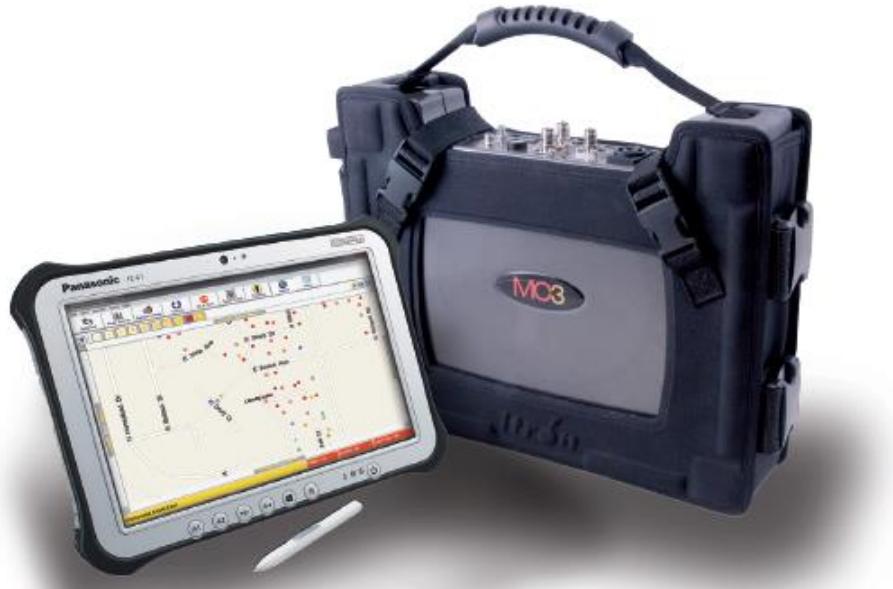
FIG 6:
(Tablet is pedestal mounted in the Drive-by Vehicle for safe operation)

In addition, upgrading to the new Itron Tablet version of the MCLite (i.e., the MC3 SME, FIG6 – next page) **allows Ramon to delegate Drive-by meter reading to others, and Ramon focus on other work.**

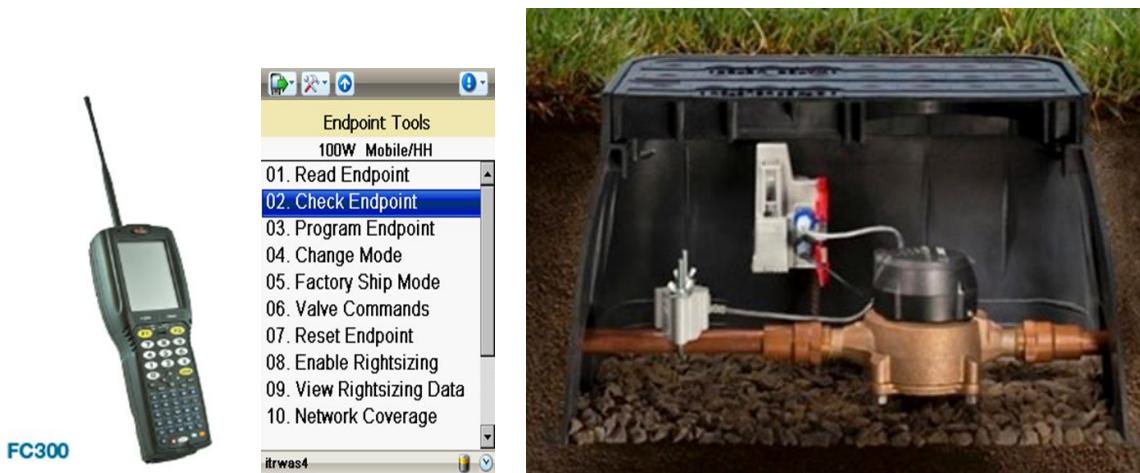
FIG 8:
Field Deployment Manager
Endpoint Tools Mobile Application Guide

Itron has a super user-friendly **Check Endpoint** installation process to follow every time a ERT is installed that confirms the ERT is working to specifications and that the ERT will quickly be read by the FC300 during the monthly Opa-locka meter reading process (See FIG 8).
